SB 630797

Reference: Date: WT02-001 NTB02-030 March 15, 2002

2002 ALTIMA WHEEL COVER SQUEAK/CLICK NOISE

APPLIED VEHICLES: 2002 Altima (L31)

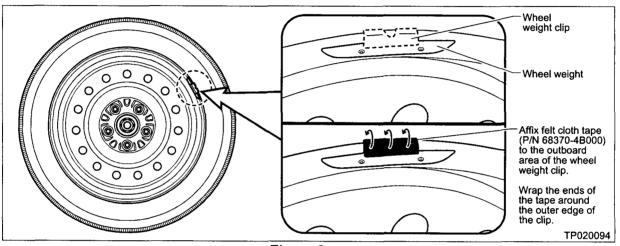
Figure 2

Contact between the clip portion of the factory wheel weight and the outer edge of the cover.

- 1. Remove the affected wheel cover(s).
- 2. Clean the entire surface of the wheel weight (and its clip) with Genuine Nissan Brake Cleaner. Allow the weight and clip to dry completely.
- 3. Attach a strip of Felt Cloth Tape to the factory wheel weight (as shown in Figure 2, below).
- 4. Wrap the ends of the tape around the outer edge of the clip (see Figure 2).
